FIFTH QUARTERLY PROGRESS REPORT  
(May 1984 - December 1984)

DEVELOPMENT OF SAFETY CRITERIA FOR EVALUATING  
CONCRETE TIE TRACK IN THE NORTHEAST CORRIDOR  
(CONTRACT DTFR53-83-C-00009)

U.S. DEPARTMENT OF TRANSPORTATION  
FEDERAL RAILROAD ADMINISTRATION

MARCH 4, 1985

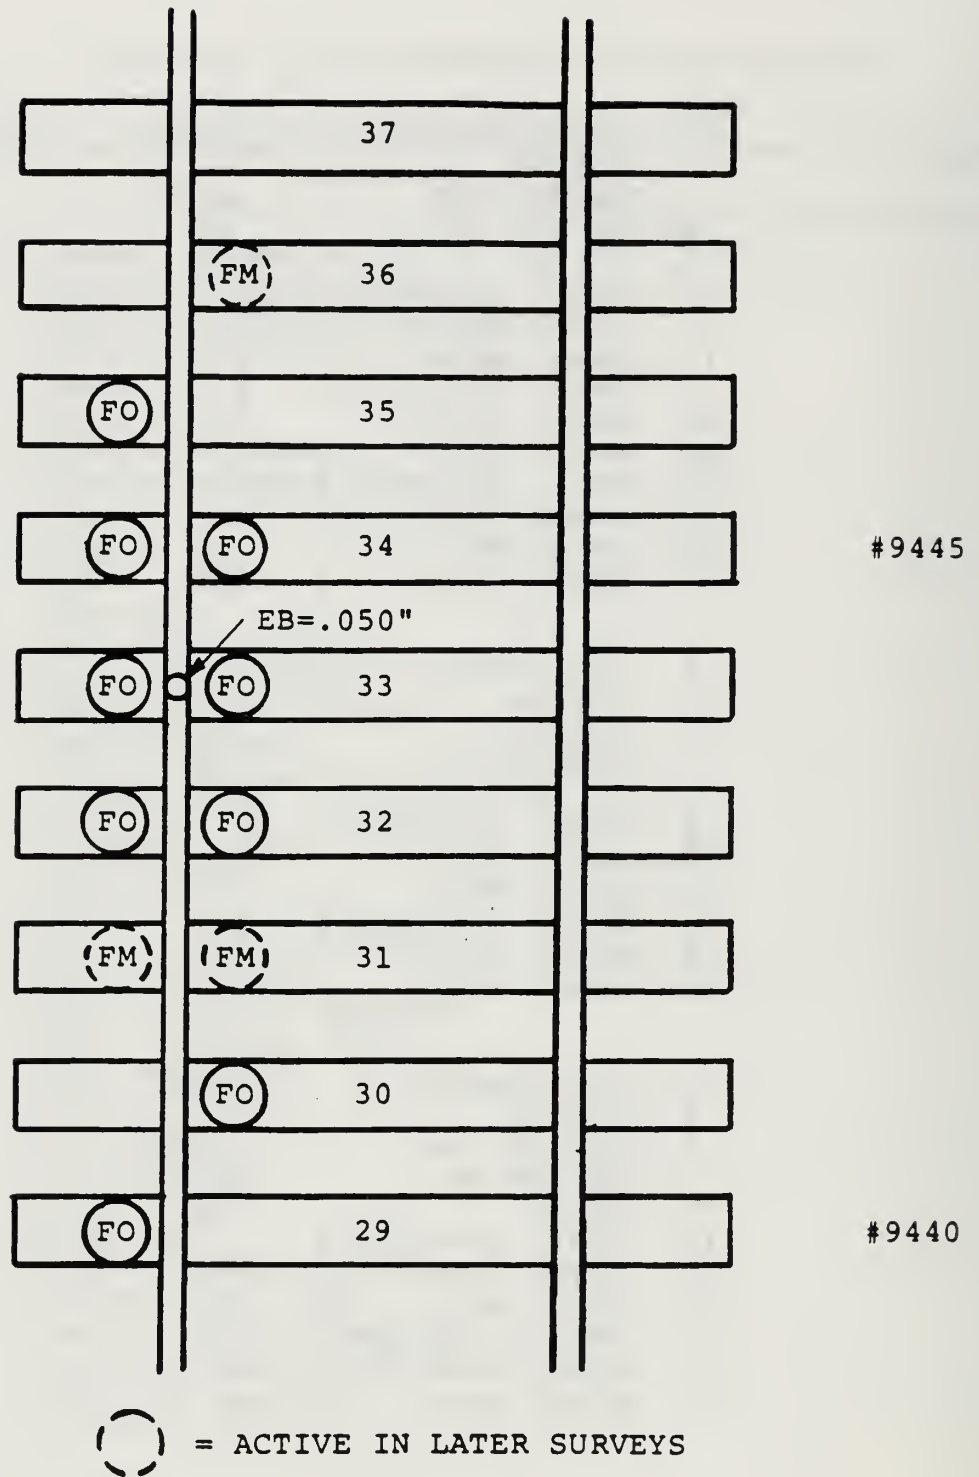
SITE 1, SECTION 11, MP 67.57

The results from all four track walker surveys for the four test sites were loaded into Battelle's BASIS data management program and verified by comparing specific track component fault occurrences with the numbers previously observed. Descriptions of the four test sites, each including between 10,475 to 15,450 concrete ties, are given in Table 1. Individual track component faults were entered for specific tie sequence numbers by the descriptive code given in Table 2. An example of the data storage format for three successive ties in Site 1 is given in Figure 2. The pattern of faults found in Survey 1 near the engine burn (EB) at Tie #33 is shown in Figure 3.

FIGURE 3. EXAMPLE OF TRACK COMPONENT FAULTS OBSERVED DURING FIRST SURVEY OF TEST SITE #1, SECTION #11

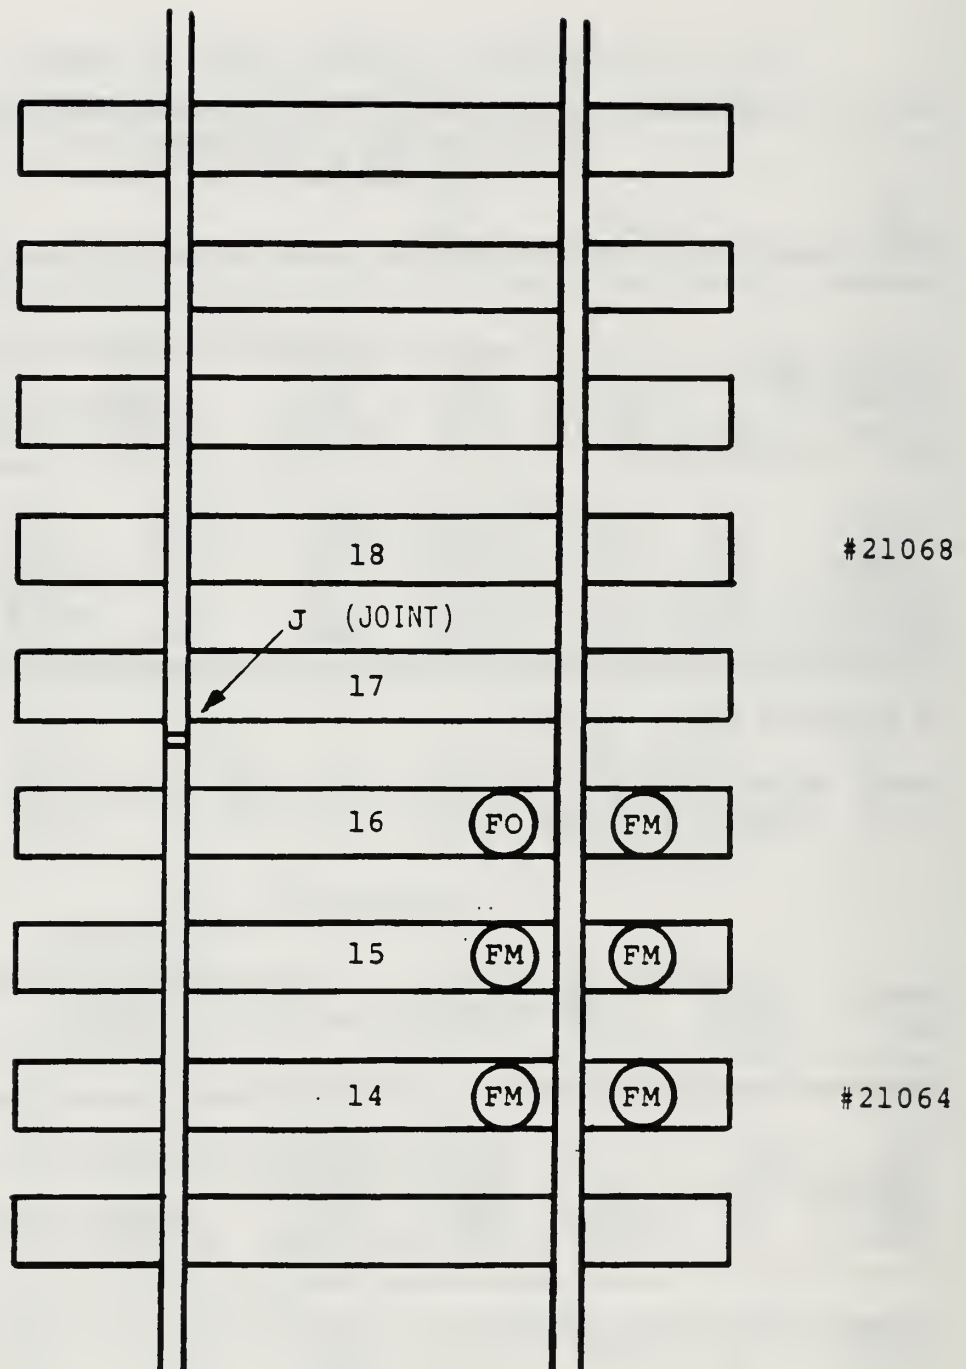
SITE 2, SECTION 8, MP 47.62

FIGURE 4. EXAMPLE OF FASTENER FAULT CLUSTERING ON RAIL  
OPPOSITE A RAIL JOINT OR BATTERED WELD

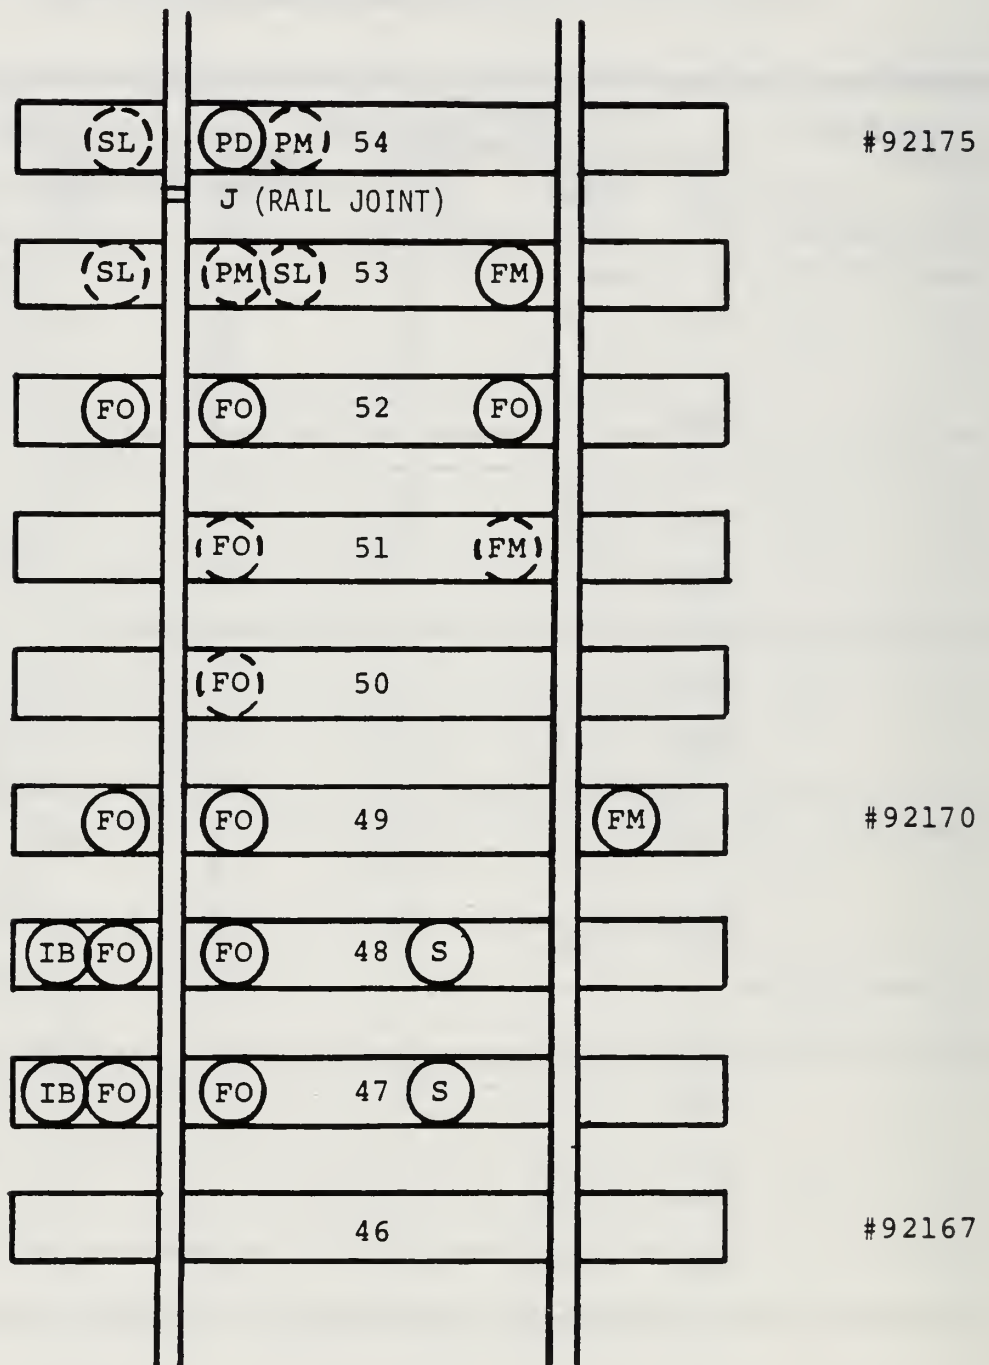
SITE 5, SECTION 14, MP 63.74

Site 5 (with the more resilient Trelleborg pads) had the highest incidence of pads moving, damaged or missing. Site 5 also had the highest number of skewed ties. One of the busier component fault arrays within Site 5 is shown in Figure 5 clustered about a rail joint. Two of the skewed ties (47 and 48) are associated with clips out on both field and gage side and field-side insulators broken, all on one rail. Two other ties (56 and 57) that skewed by a later survey are associated with one clip out, three clips moving on one rail, in Figure 5.

FIGURE 5. EXTENSIVE TRACK COMPONENT FAULT PATTERN NOTED IN SURVEY OF TEST SITE 5

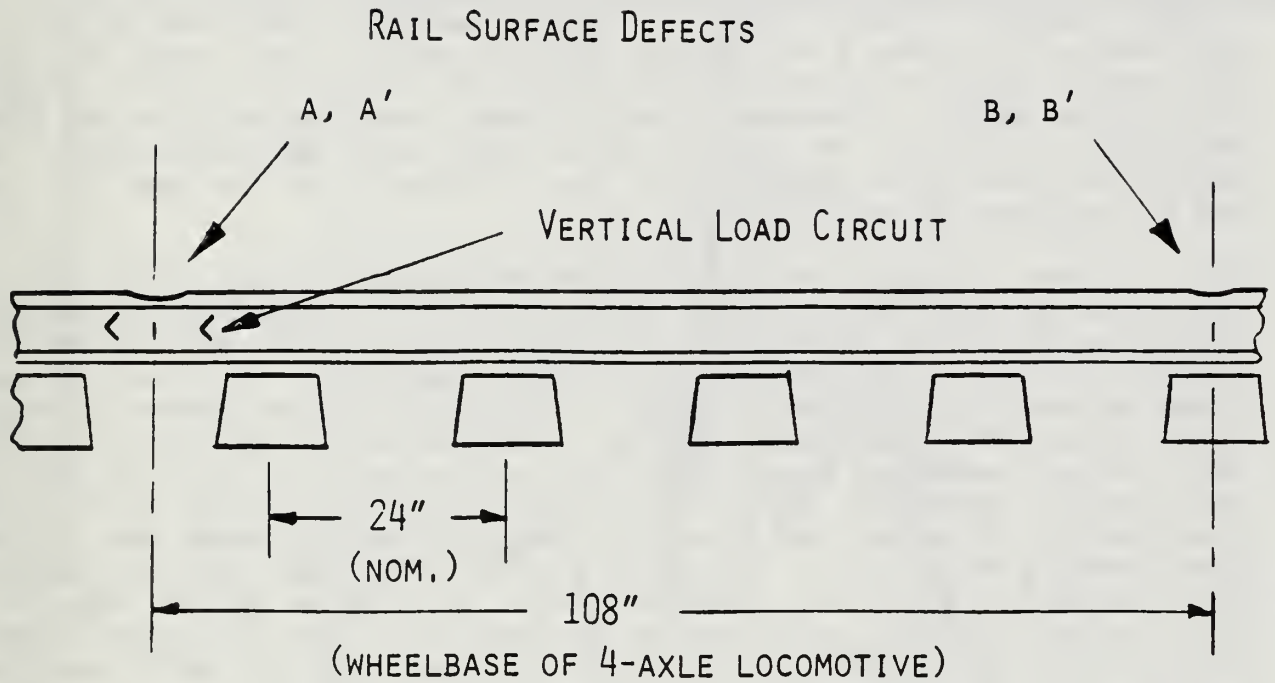
RAIL SURFACE DEFECT ARRAY IN SECTION 22 (TTC)

The simulated engine burns were at first ground in on the plane of the track, but it was quickly noted that the worn running surface of the rail (approximately a 1:5 cant angle) put the anomalies at the extreme field side of the rail, where contact with the worn wheel profiles of the FAST train was minimal. The anomalies were therefore reground in line with the rail surface cant angle. Originally, the anomalies were ground in to achieve impacts ranging from 25 to 100 percent of the intended maximum 90,000-lb load. Considerable modification was necessary, probably due to the rail and FAST train wheel profile wear:

FIGURE 6. PATTERN OF SIMULATED ENGINE BURN DEFECTS USED IN TRACK COMPONENT DEGRADATION RATE TESTS

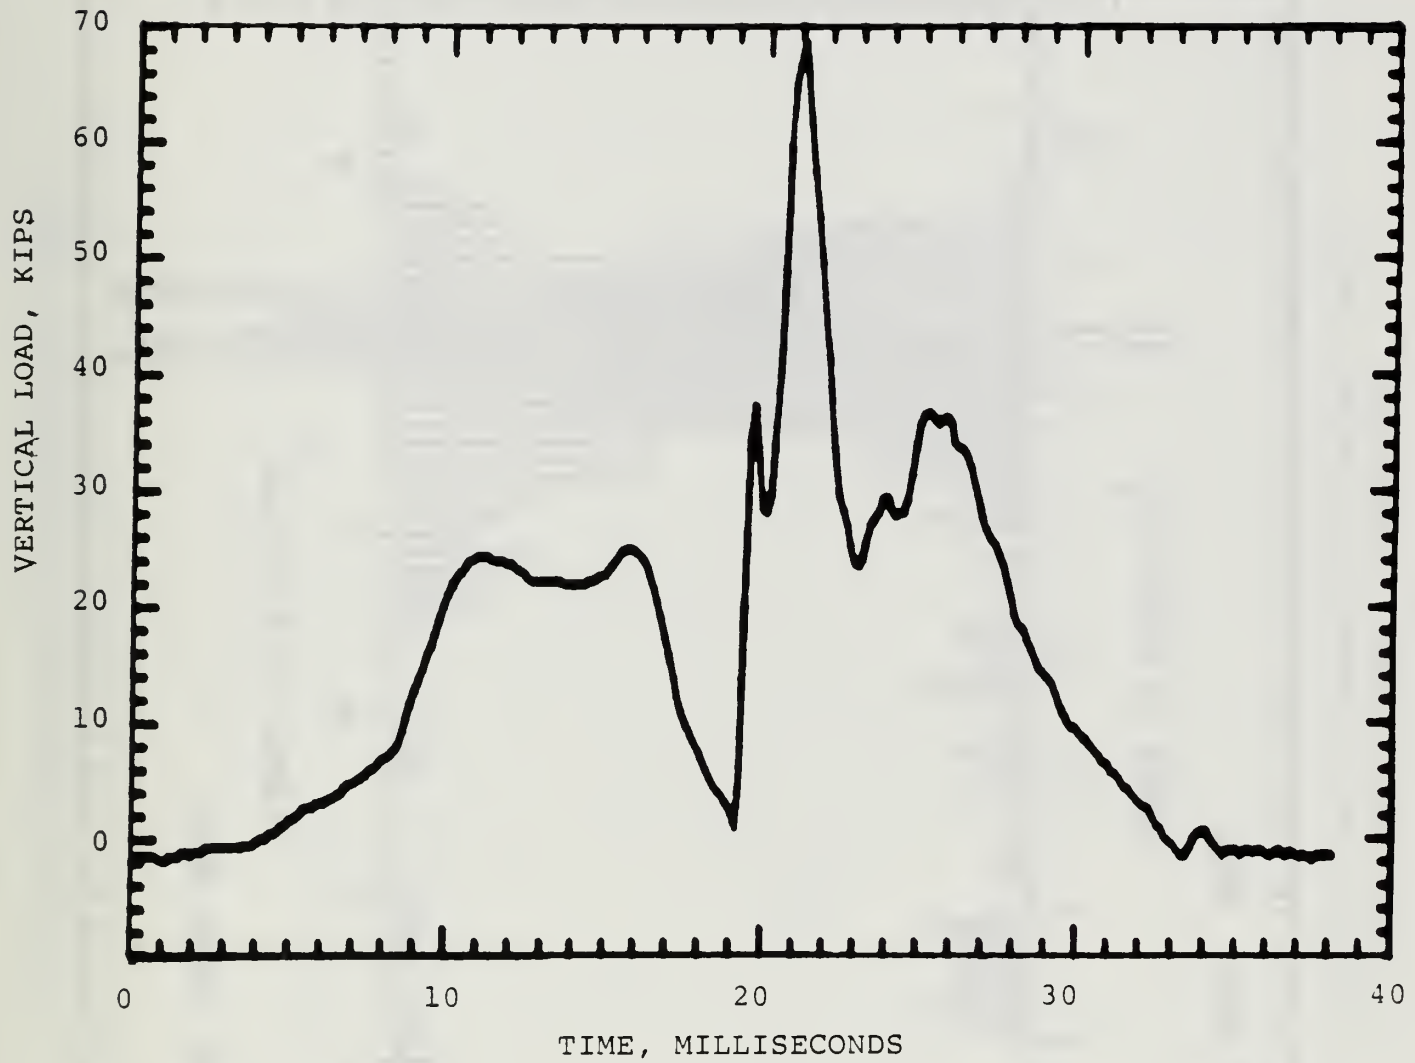
FIGURE 7. WHEEL IMPACT LOAD UNDER LEADING AXLE OF GP-40 LOCOMOTIVE, RAIL DIVOT DEPTH = 0.063" (96IVX)

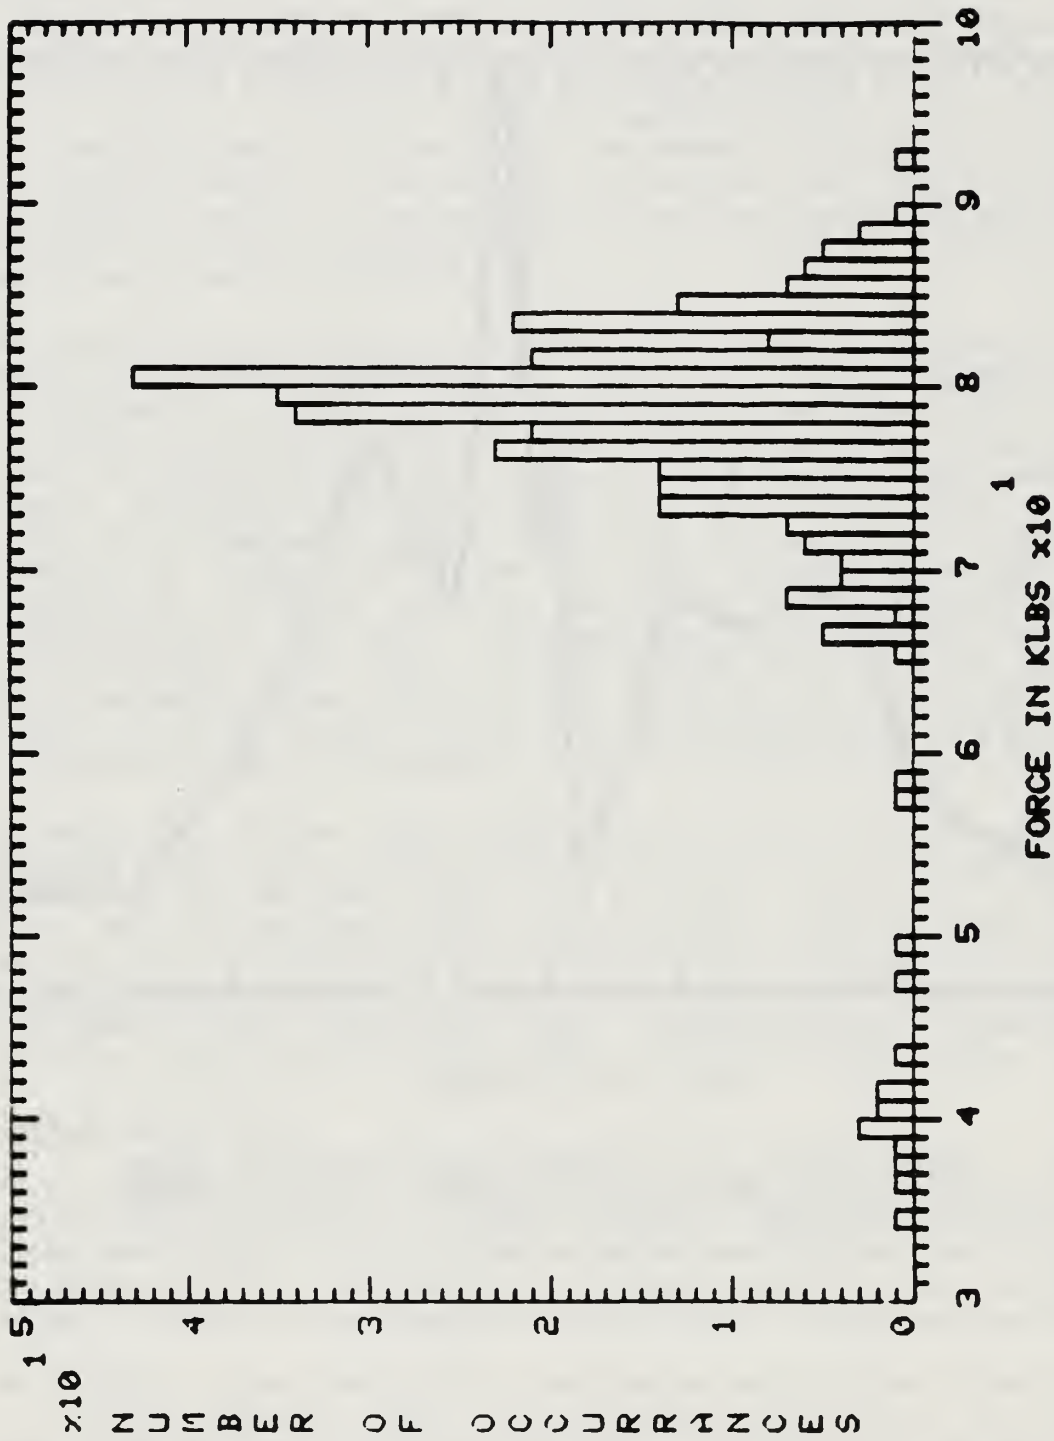
FIGURE 8. VERTICAL LOAD HISTOGRAM WITH ORIGINAL (.063")  
SIMULATED ENGINE BURN ON CONCRETE-TIE TRACK

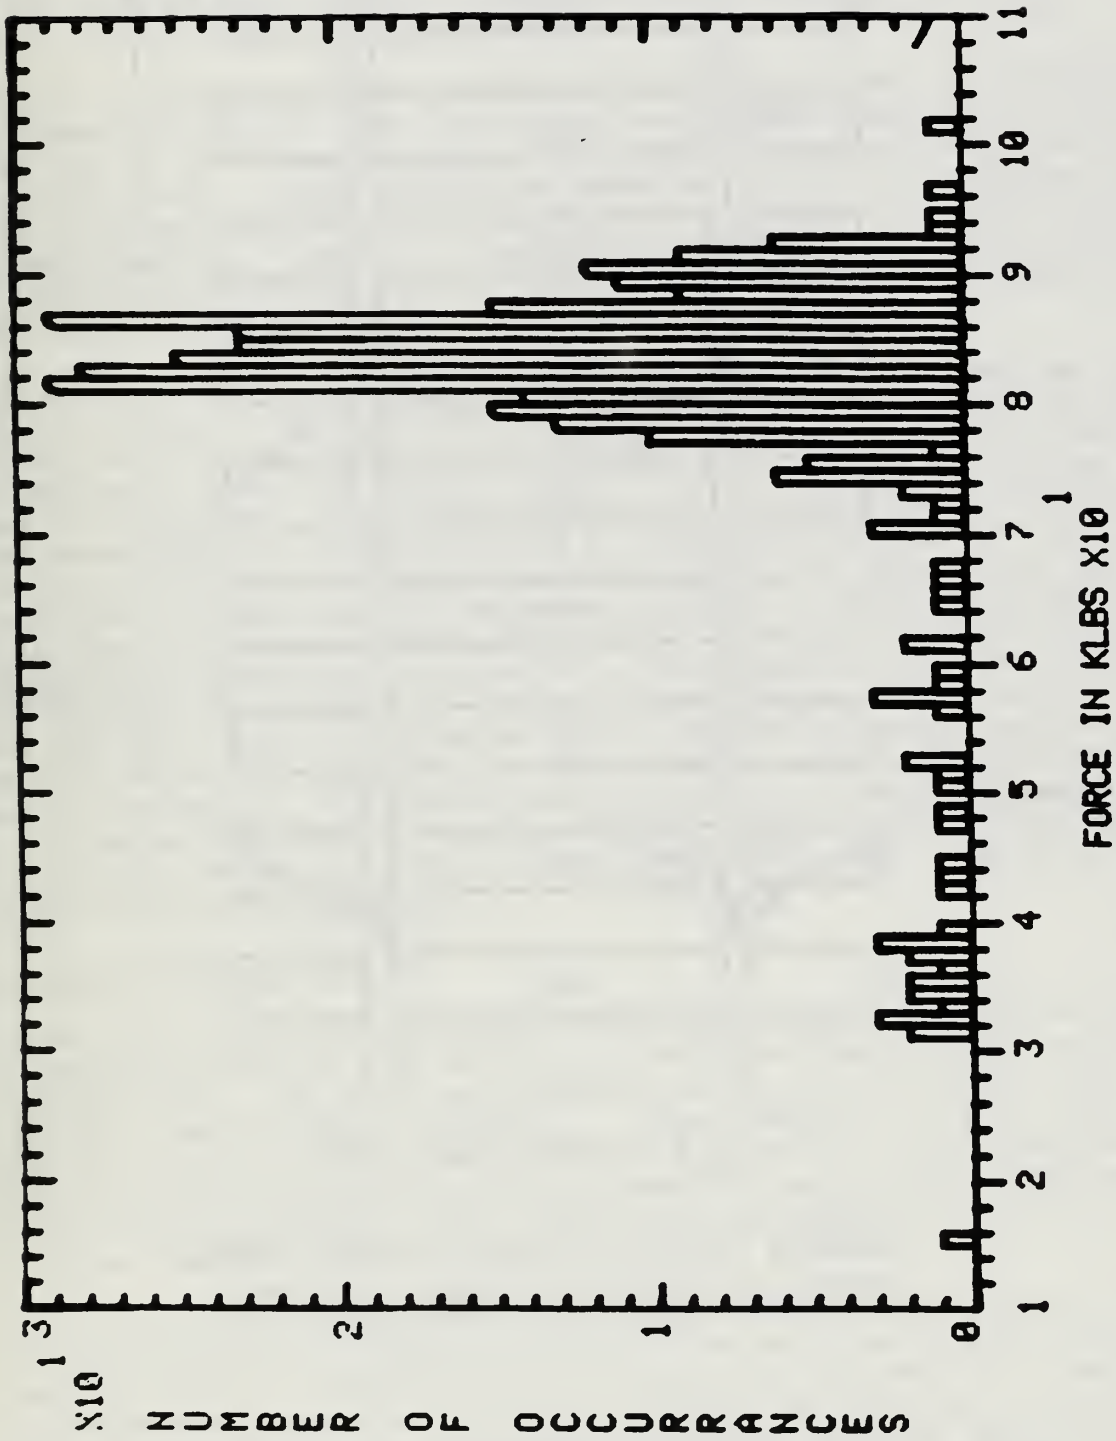
FIGURE 9. VERTICAL LOAD HISTOGRAM WITH DEEPER (.080")  
SIMULATED ENGINE BURN -- 4 MGT DATA

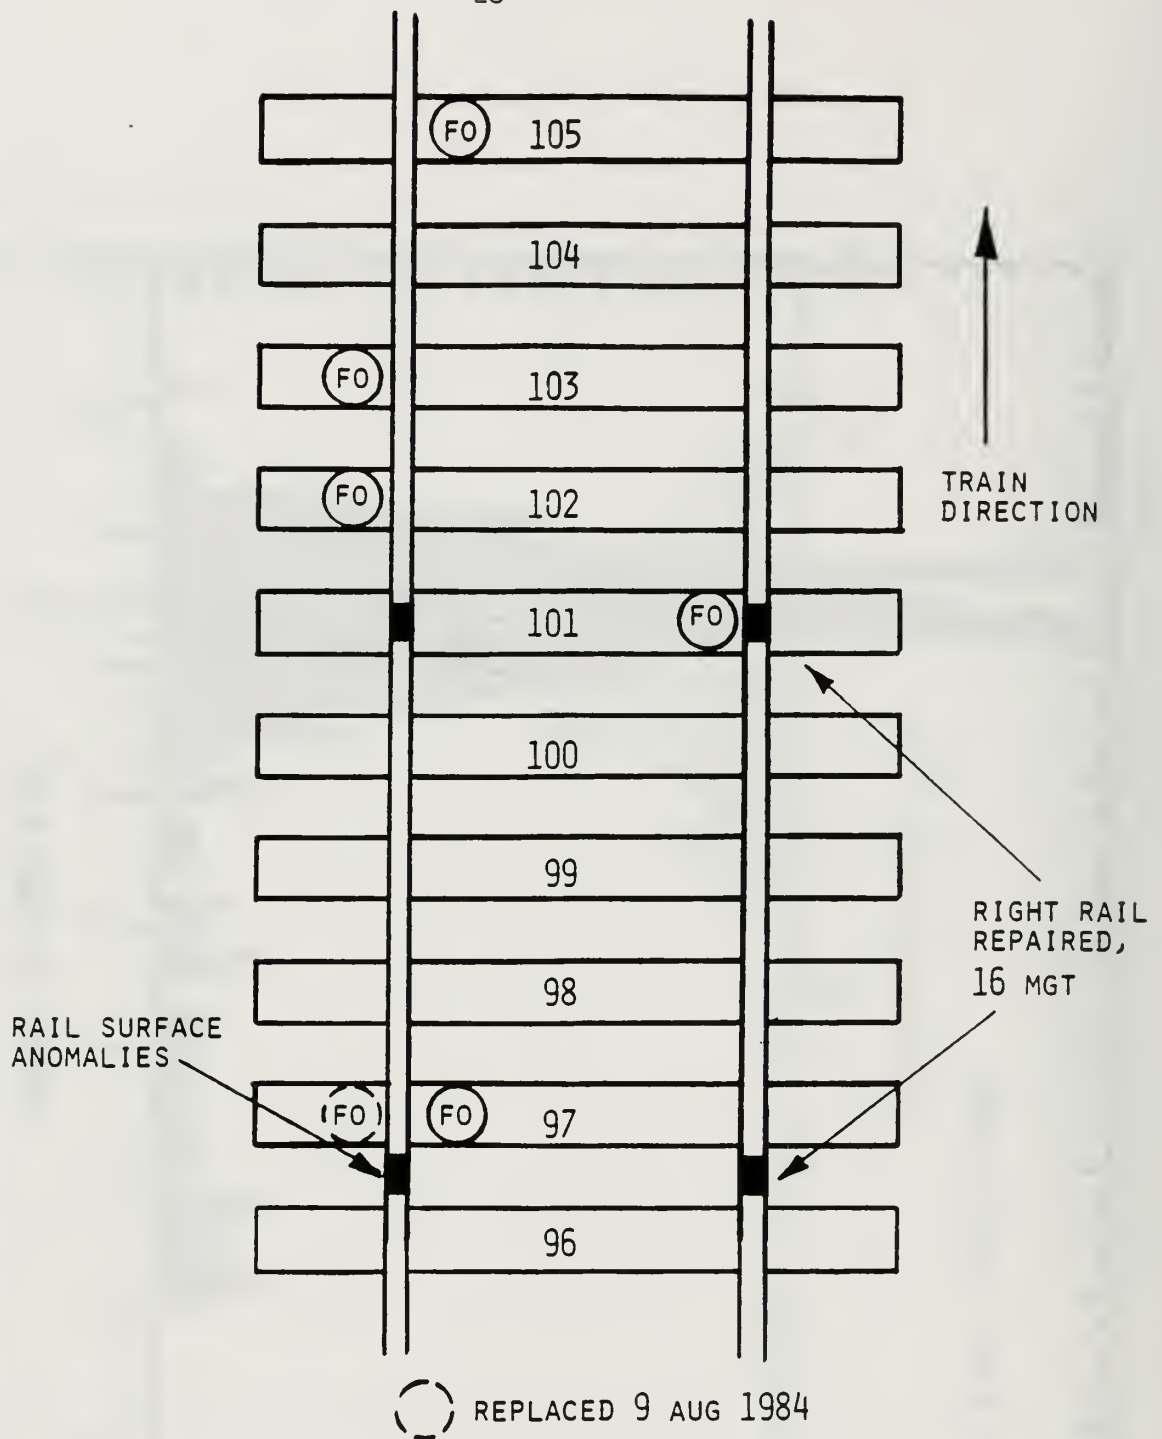
FASTENER FALLOUT PATTERN AT 0.080" DIVOTS,  
SECTION 22 CONCRETE TIE TRACK (AAR/TTC)

Currently, the fastener fault pattern shown in Figure 10 exists at the 0.080-inch anomalies with an accumulated tonnage of 18 MGT. A little pumping and some dust around the ties has been noted. One additional gage-side clip was out at Tie 0121. No other problems such as tie cracking or shoulder/insert failures have been reported. Runs since about 15 MGT have been conducted without track lubrication, and more evidence of clip movement and ballast migration from cribs has been reported during these "dry" runs. This may be due to higher general track vibration levels, even on tangent track, during the unlubricated runs.

FIGURE 10. TRACK COMPONENT DEGRADATION PATTERN WITHIN  
IMPACT TEST SITE, SECTION 22, AT 18 MGT

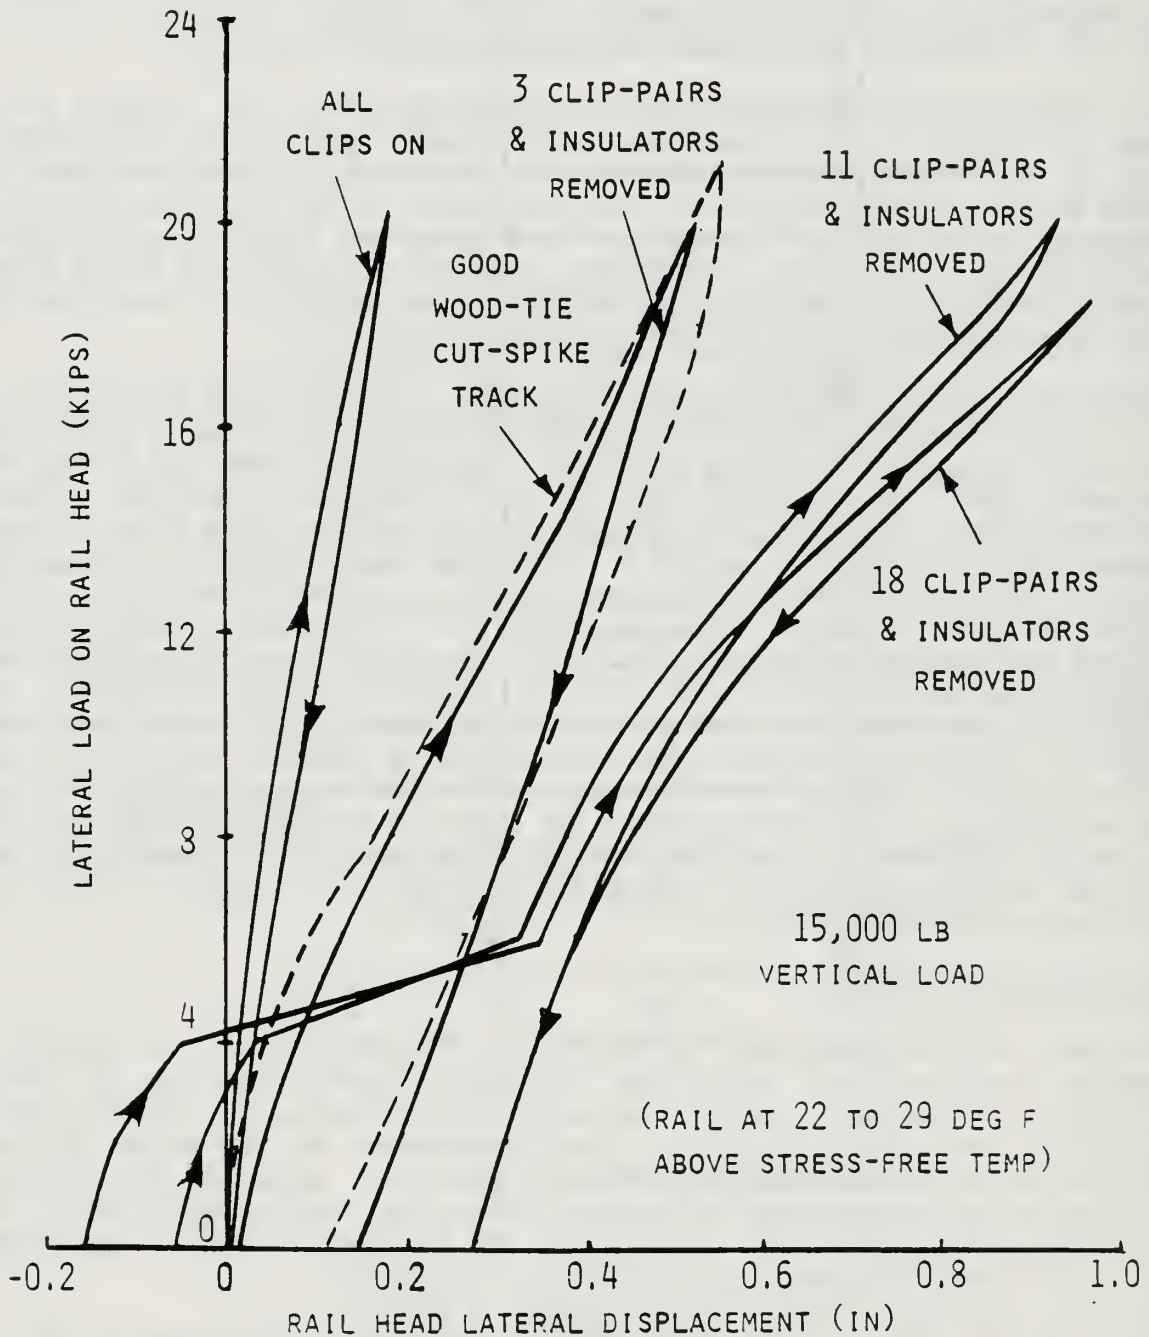
Typical railhead lateral force/deflection curves from these track strength tests are shown in Figure 11. For comparison, test results from similar measurements from 1979 on the TTC Railroad Test Track wood-tie, cut-spike track are shown in the dashed curve. Nominal deflection characteristics of the wood-tie track are seen to be equivalent to the NEC concrete-tie track with 3 clip-pairs/insulators missing in a row. These tests showed that with an exceptional 11 to 18 clip-pairs/insulators missing, the rail was still retained within safe gage-widening limits by the shoulder/inserts of NEC track configuration.

FIGURE 11. RESULTS OF TRACK STRENGTH MEASUREMENTS ON NEC CONCRETE TIE TRACK STRUCTURE -- SECTION 22, TRANSPORTATION TEST CENTER FAST TRACK LOOP

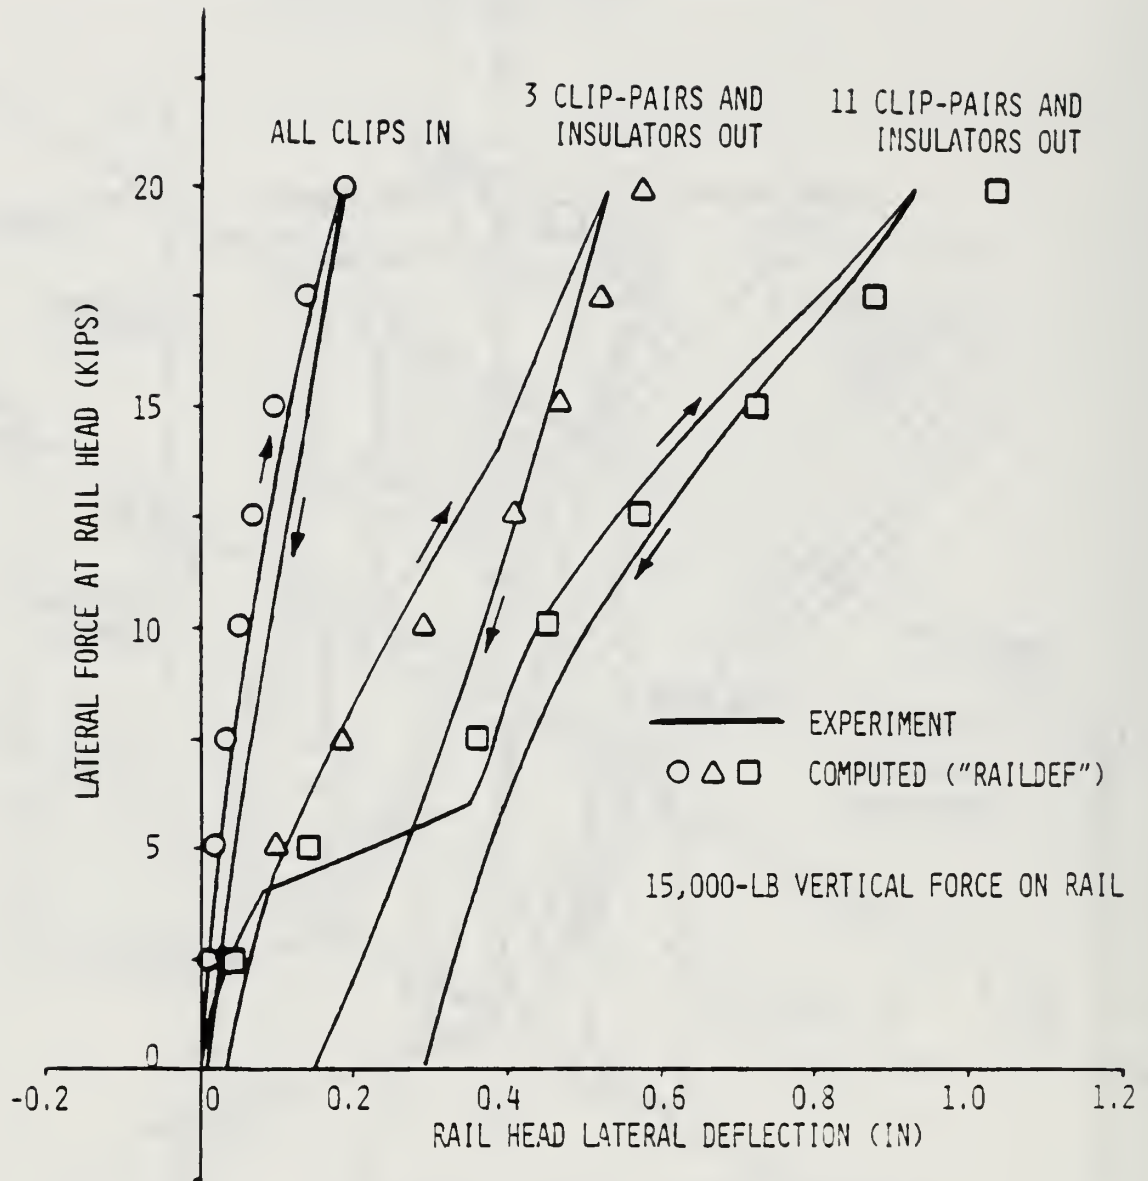
Comparisons of rail head and rail base lateral deflections under combined vertical and lateral loads predicted by RAILDEF and measured in tests are given in Figures 13 and 14. Predicted results are generally conservative in that slightly more deflection is computed for a given load than the tests show. Parameters for the model were based on a combination of laboratory tests of individual components and manufacturers' catalog data.

FIGURE 13. COMPARISON OF PREDICTED WITH MEASURED RAIL HEAD LATERAL DEFLECTIONS WITH RAIL FASTENERS REMOVED -- NEC CONCRETE TIE TRACK

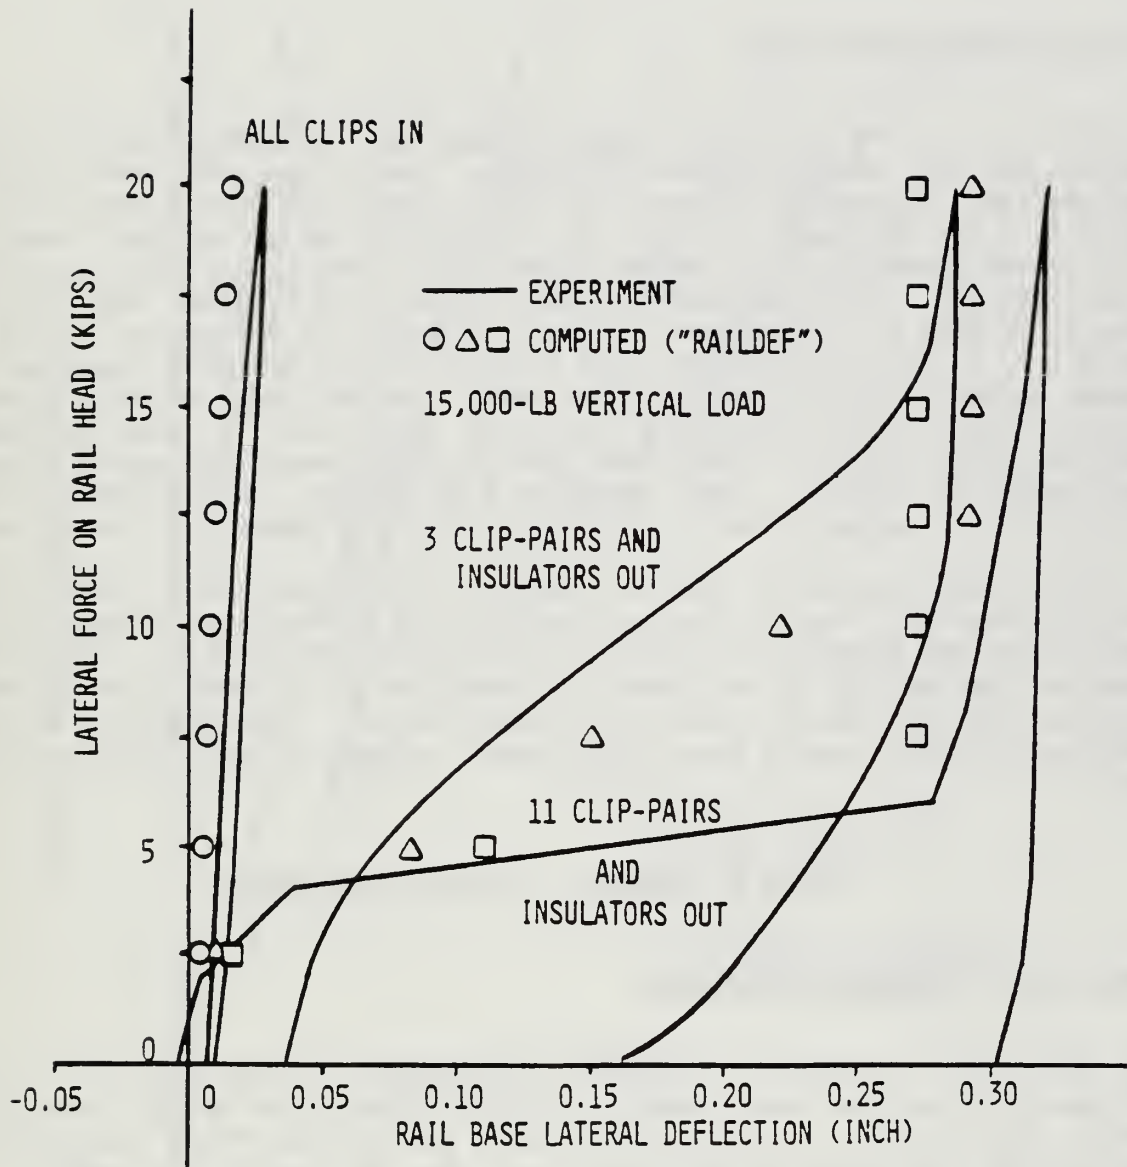
FIGURE 14 . COMPARISON OF PREDICTED WITH MEASURED RAIL BASE DEFLECTIONS -- NEC CONCRETE TIE TRACK

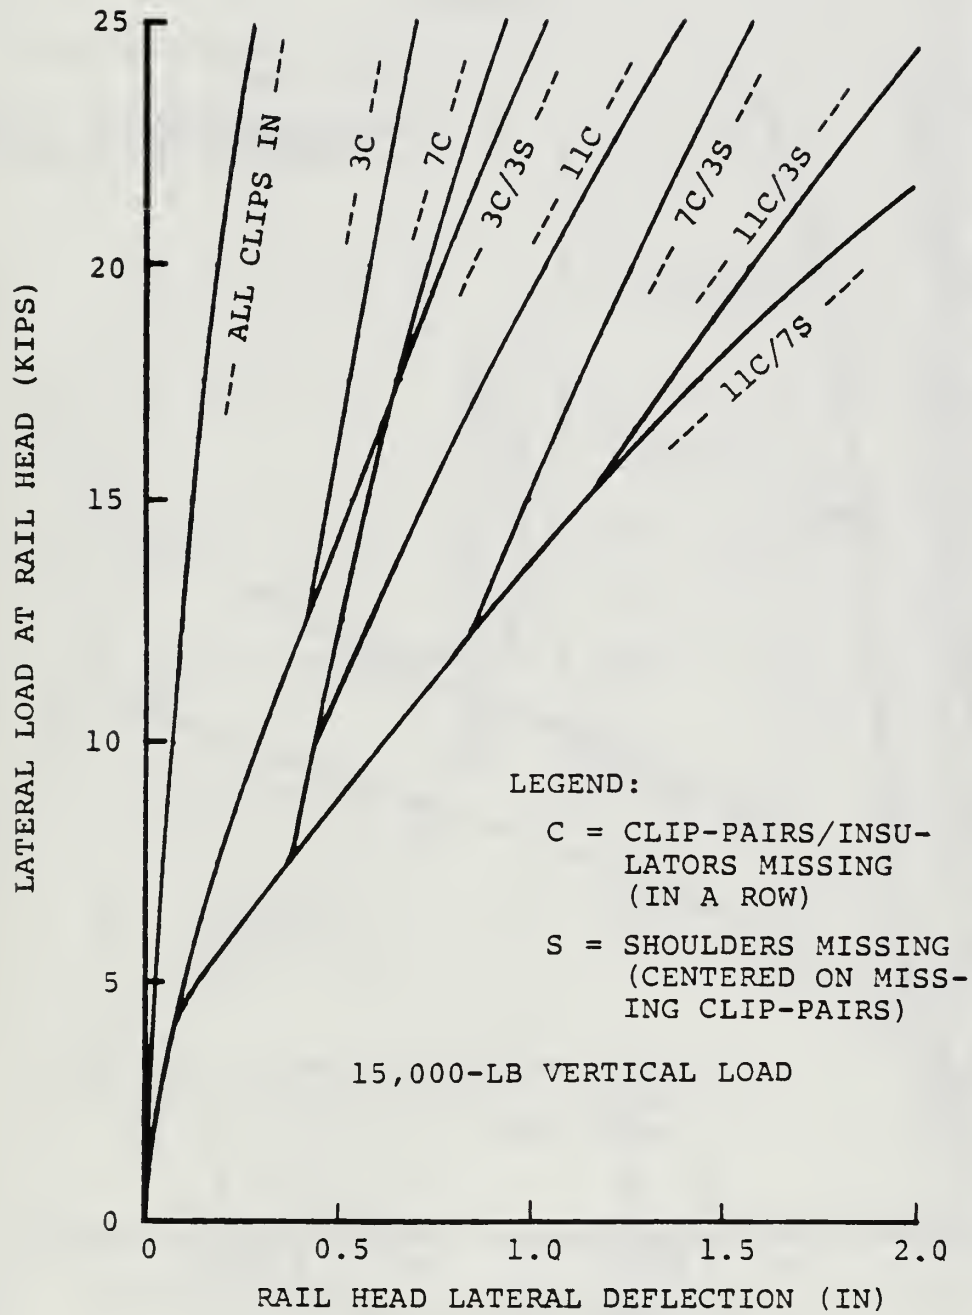
Verification of the analytical model RAILDEF then allowed predictions of rail deflections with shoulder/inserts missing. Predictions with several different combinations of missing fasteners (clip-pairs and insulators) and shoulder inserts in a row are shown in Figure 15. The predicted deflections form a "tree" with curves branching at different points as clearances are taken up and shoulders contacted. The rather extreme combination of 11 fasteners and 7 shoulder/inserts missing in a row shows less than 1.5 inches of deflection for L/V ratio below 1.2, a value normally produced for only very short time durations. This amount of gage widening, assuming the load on one rail only (which is expected on tangent track) would not cause a wheel-drop derailment. It must be emphasized that these predictions and the track strength tests represent loading to expected worst-case L/V ratios. Track geometry measurements, on the other hand, are conducted with nominally-small lateral loads on the geometry car wheelsets.

FIGURE 15 . PREDICTED RAIL LATERAL DEFLECTIONS  
UNDER VERTICAL AND LATERAL WHEEL LOADS  
-- NEC CONCRETE TIE TRACK WITH MISSING  
FASTENERS AND SHOULDERS

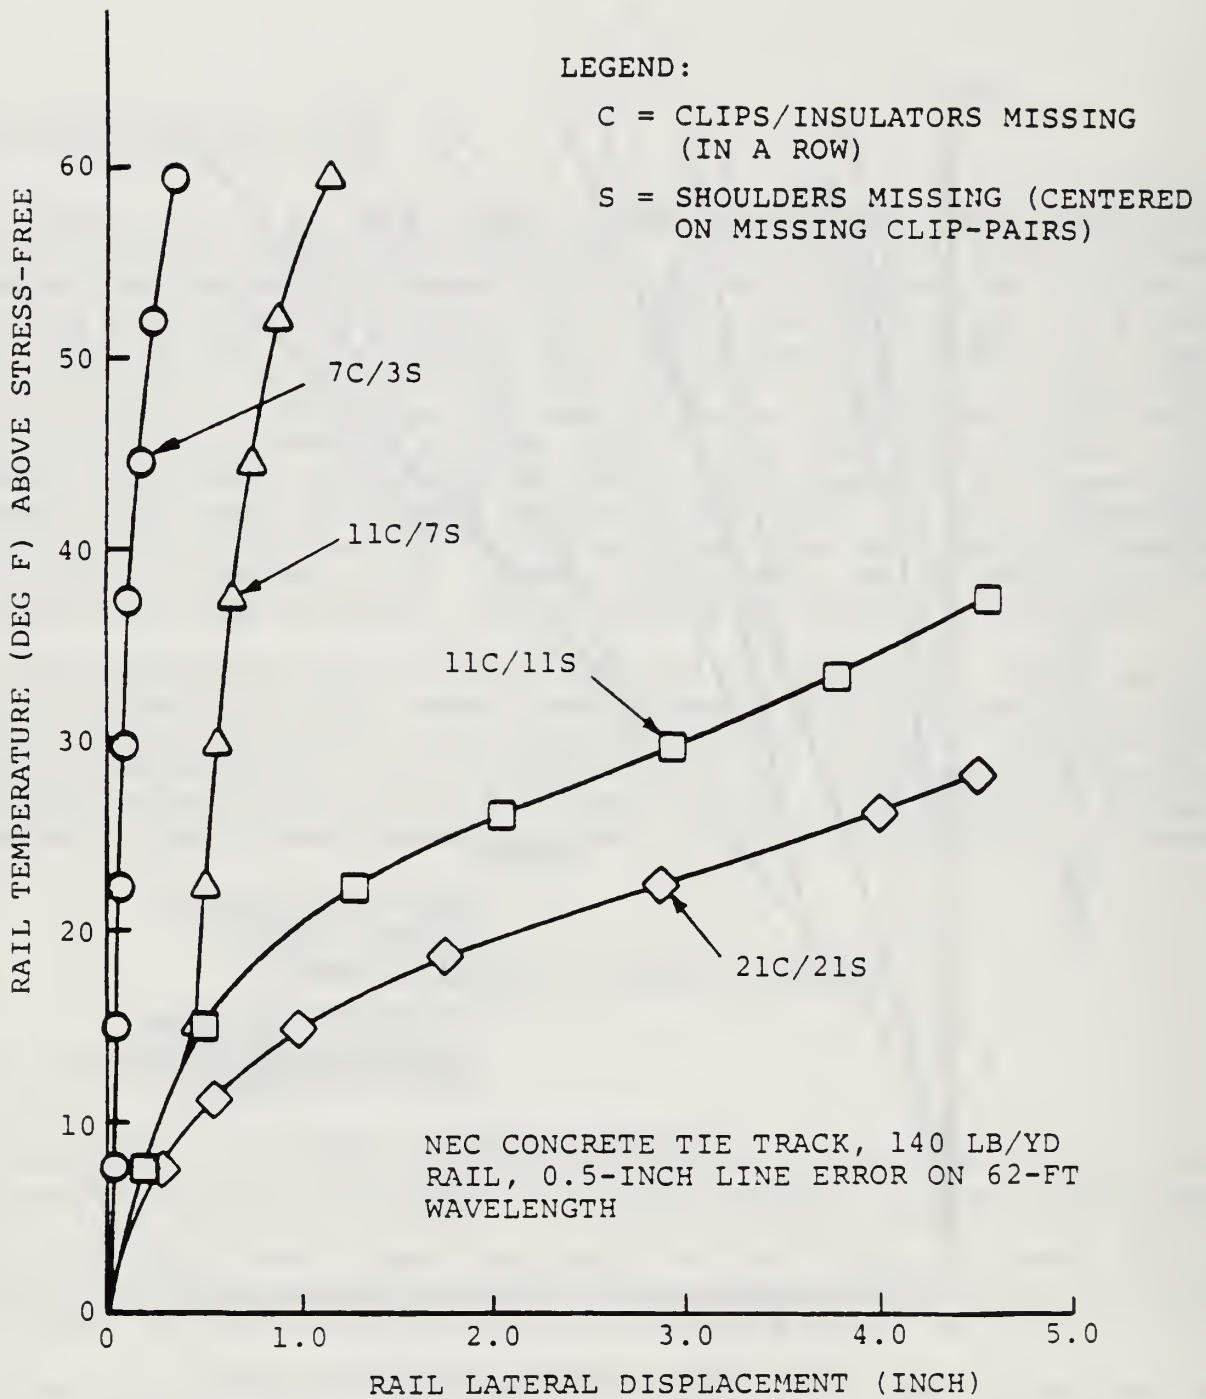
A similar verification of the nonlinear rail buckling model TBTRACK was not possible from test results. Several combinations of missing fasteners and shoulder/inserts are examined in the predictive curves of Figure 16. Note that rail buckling instability is not predicted even for 11 fasteners and 7 shoulders missing, and the maximum Class 6 alignment error. Removing just a few more shoulders, however, would result in a rapid increase in deflection with thermal load.

FIGURE 16. PREDICTED LATERAL DISPLACEMENT OF RAIL UNDER THERMAL LOAD -- CONCRETE TIE TRACK WITH MISSING FASTENERS AND SHOULDERS
